North Sandy Pond Management Plan

NOVEMBER 2023

Upstate Freshwater Institute
224 Midler Park Drive
Syracuse, NY 13206

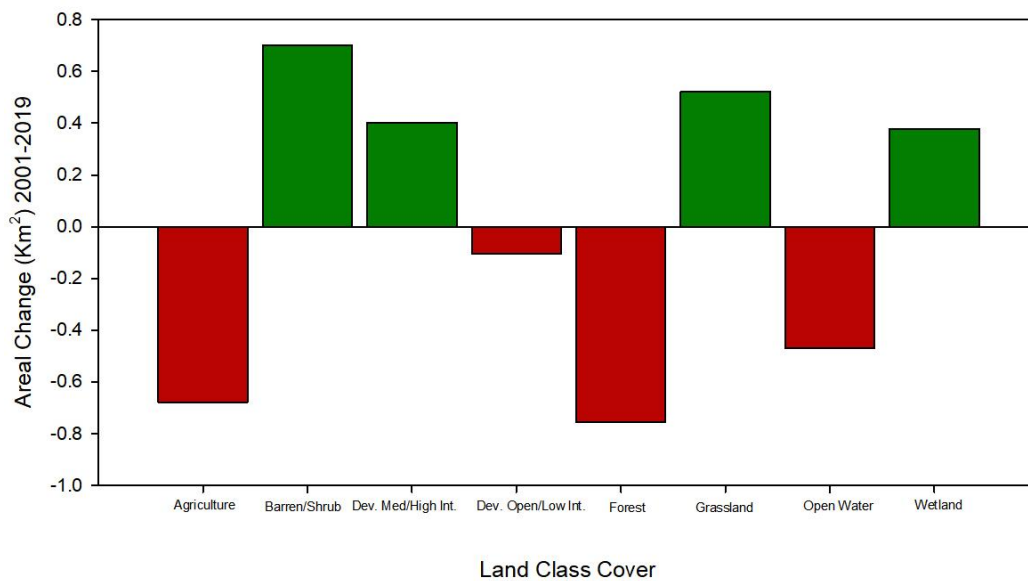
Figure 5. Change in land cover categories for the North Sandy Pond watershed from 2001 to 2019 (Source: NLCD).

Land cover at the watershed scale over an 18-year period (2001 to 2019) has remained largely stable over the past two decades (**Figure 5**), with a few patterns of note. Over this period, there has been a reduction in agricultural land and forests, with an increase in moderately intensive development and grasslands (perhaps suggesting a conversion of active agricultural land to fallow properties). Forests remain the dominant land cover type in the watershed at approximately 60% of the total area (**Figure 4**). Wetlands in the North Sandy Pond watershed are notable due to their ecological and water quality importance. Wetland areas can act as sediment and nutrient sinks during the growing season, but also can contribute naturally to lake nutrient levels during periods of decomposition of organic matter. The primary wetland areas within the North Sandy Pond watershed are found to the north (*e.g.*, Lakeview Wildlife Management Area) and near the inlets of the main tributaries (**Figure 4**).

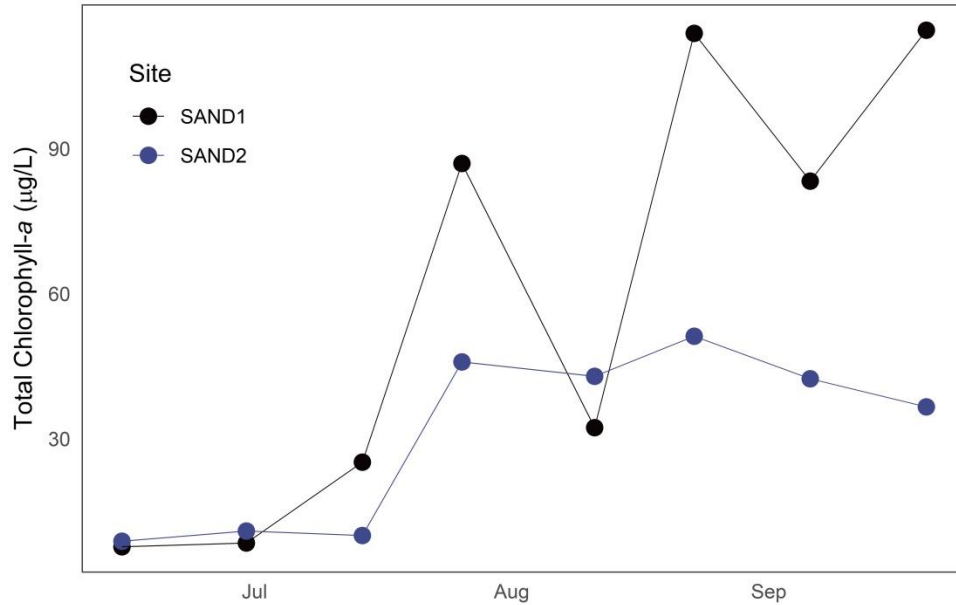
Figure 12. Total chlorophyll-a ($\mu\text{g/L}$) during 2022 monitoring of North Sandy Pond at sites SAND1 and SAND2.

During the 2022 monitoring season, average Chl-a concentrations were $58.1 \mu\text{g/L}$ (+/- 43.8) at SAND1, and $31.1 \mu\text{g/L}$ (+/- 18.0) at SAND2. Chl-a concentrations were generally greater at the sampling location in the middle of the North Sandy Pond (SAND1) compared to the sampling location in northern basin (SAND2) (Figure 12). The concentrations of Chl-a measured in 2022 suggest an elevated level of phytoplankton biomass and eutrophic conditions. Wide temporal variations in Chl-a concentrations are common in productive lakes such as North Sandy Pond.

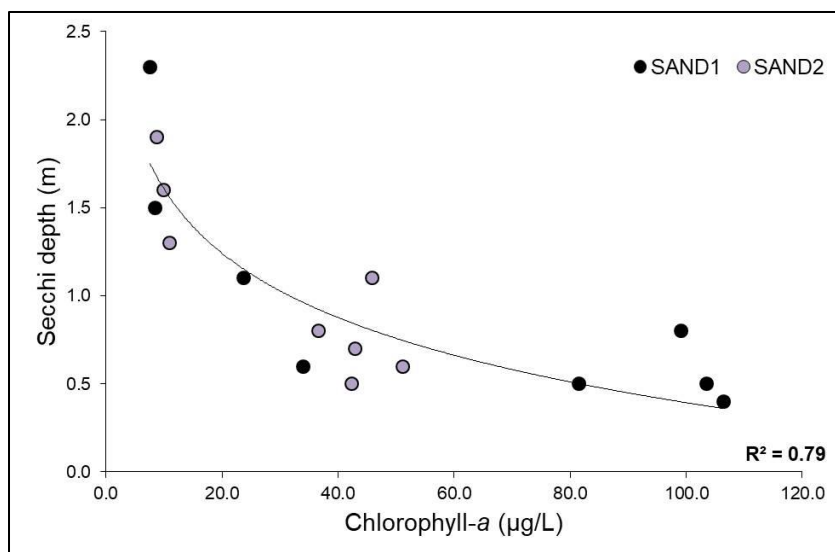
Figure 15. Relation between chlorophyll-a (µg/L) and Secchi depth (meters) in North Sandy Pond in 2022 at sites SAND1 and SAND2.

In North Sandy Pond, the relationship between Secchi depth and Chl-a is well-defined – decreased Secchi depth measurements were associated with higher concentrations of Chl-a (**Figure 15**). In other words, concentrations of chlorophyll-a explained approximately 80% of the variation in Secchi depth, suggesting algal biomass as a key determinant of water clarity in North Sandy Pond.

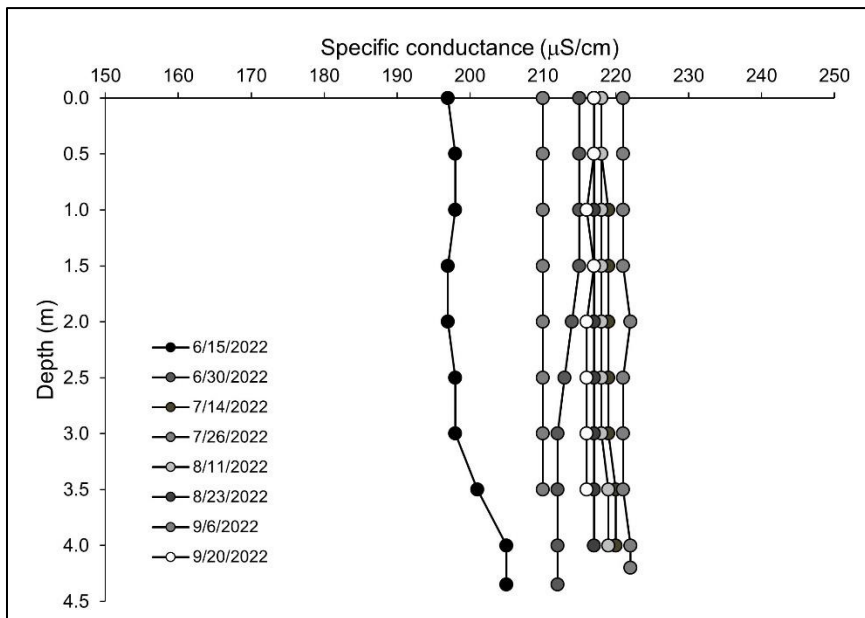
Figure 17. Specific conductance ($\mu\text{S}/\text{cm}$) profiles of North Sandy Pond from the SAND1 sampling site (43.6567, -76.1774) from June through September 2022.

Specific conductance is an aggregate measure of the summed ionic content of water and is closely related to salinity. Measurements of specific conductance in 2022 were generally uniform and values were moderate throughout the sampling period and with depth (**Figure 17**).

Measurements of pH and specific conductivity values in 2022 do not suggest potential negative impacts to aquatic life and are within the range expected for freshwater lakes.

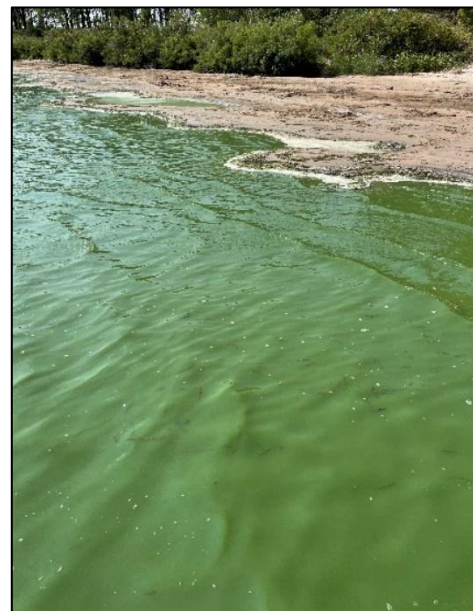
Figure 21. Shoreline bloom of CyanoHABs at North Sandy Pond in 2022 (credit: R. Fisher).

Reports CyanoHAB occurrences at North Sandy Pond have been documented since 2015 (**Table 1**) through the NYSDEC HAB Alert system. Note that the counts of CyanoHABs at North Sandy Pond are a conservative estimate – the number of actual CyanoHAB events is likely higher because the reports to HAB Alert require reports from citizens or agencies to be reported to the system. Additional documentation of

CyanoHABs is possible through visualizing and assessing satellite imagery. **Appendix 1** depicts imagery from the Sentinel-2 satellite of North Sandy Pond on select dates in 2022 (April – October). The satellite imagery depicts that increased algal growth began in 2022 around late July and continued into October.

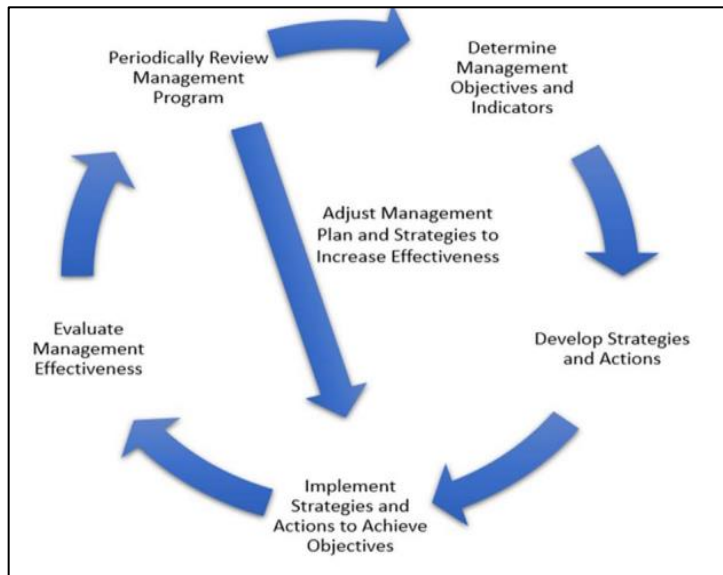
Figure 25. Diagram of adaptive management process.

An adaptive management approach is recommended for North Sandy Pond and its watershed. Adaptive management is a “build and measure” approach that acknowledges uncertainties and uses data and information to define next steps (Figure 25). This is a flexible approach for providing effective management practices within the watershed with the goal of improving water quality and minimizing the negative impacts from CyanoHABs. Participating in a lake monitoring program, such as CSLAP, will be a critical first step to advance an adaptive management framework.

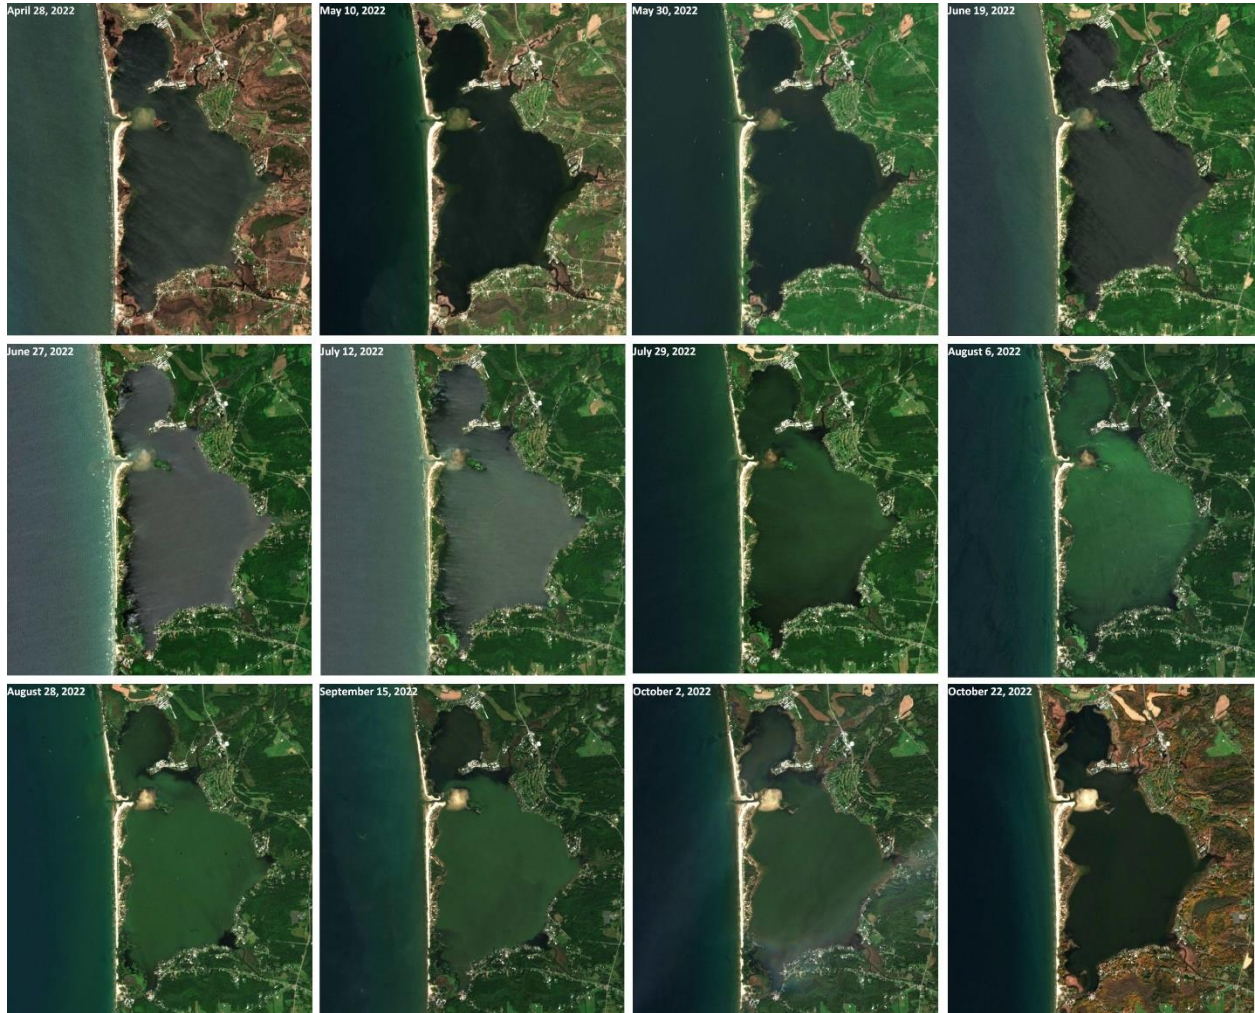
Appendix 1 – Sentinel-2 Satellite Imagery

April – October 2022
