# **Ecological Monitoring Surrounding Barrier Sites in the Village of Mexico**

**Jeremy Dietrich**

**NYS Water Resources Institute**

**August 28, 2024**

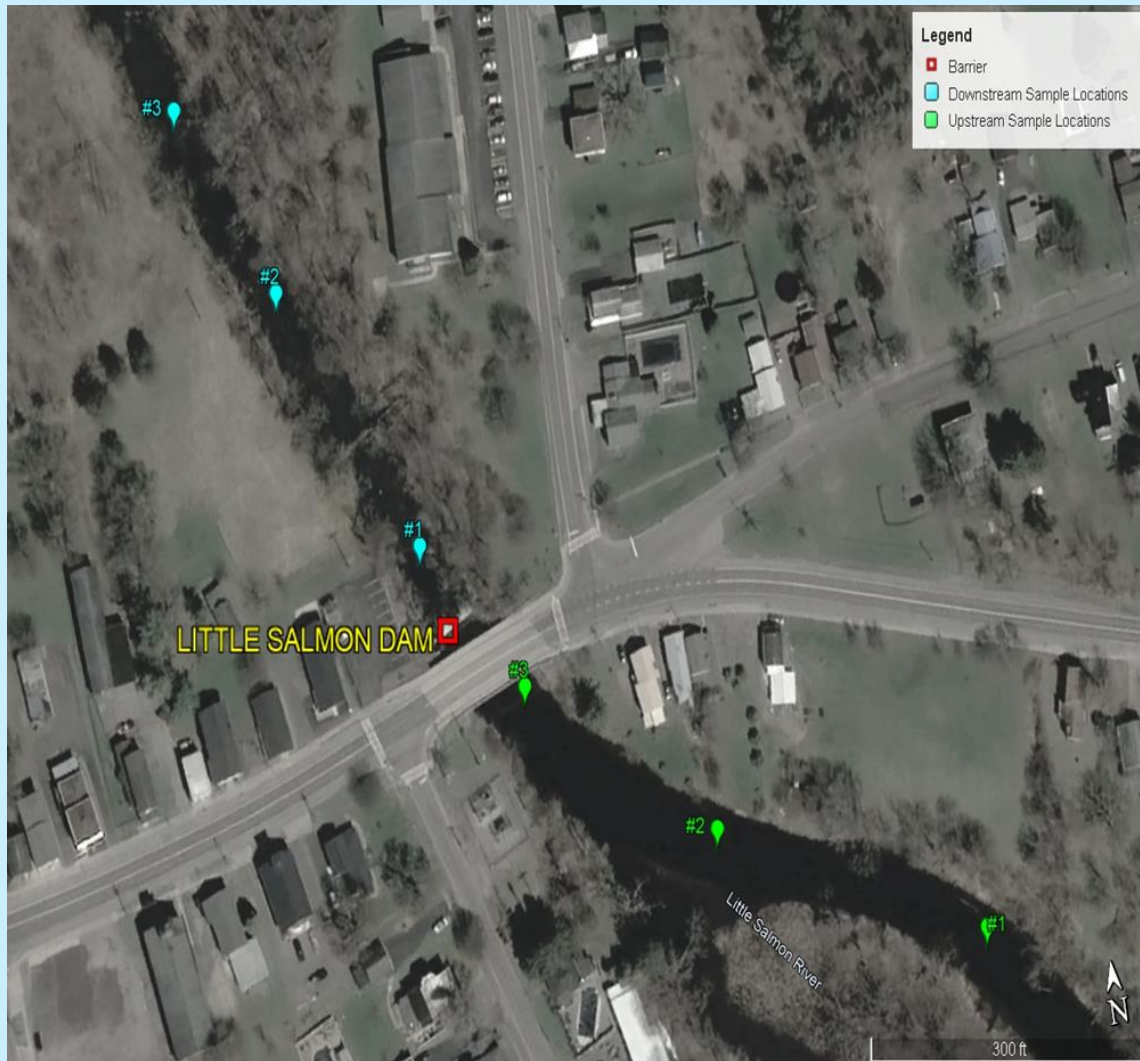
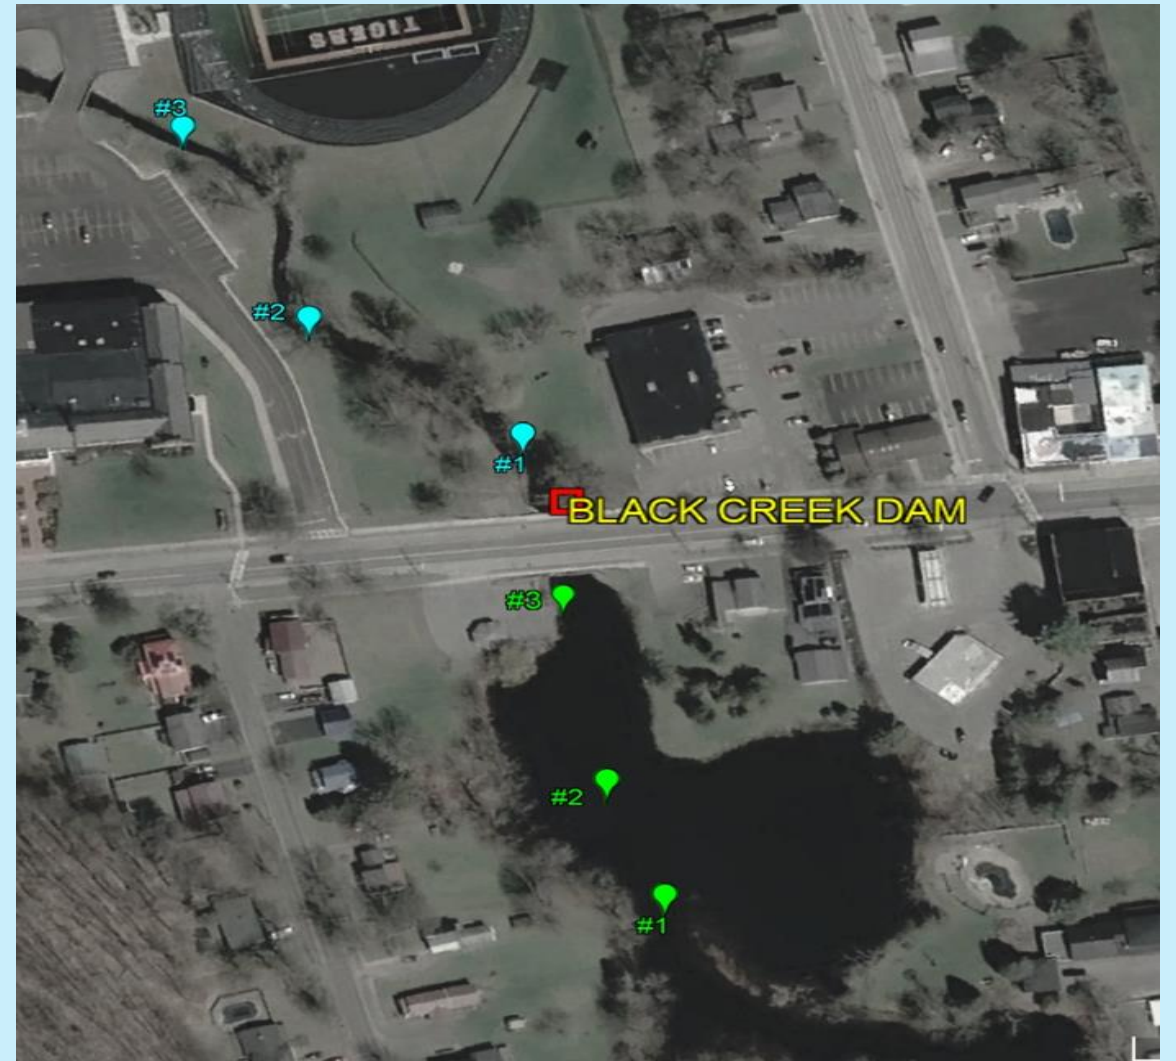
# Field Sampling Locations / Transects

Paired upstream-downstream sampling sites.

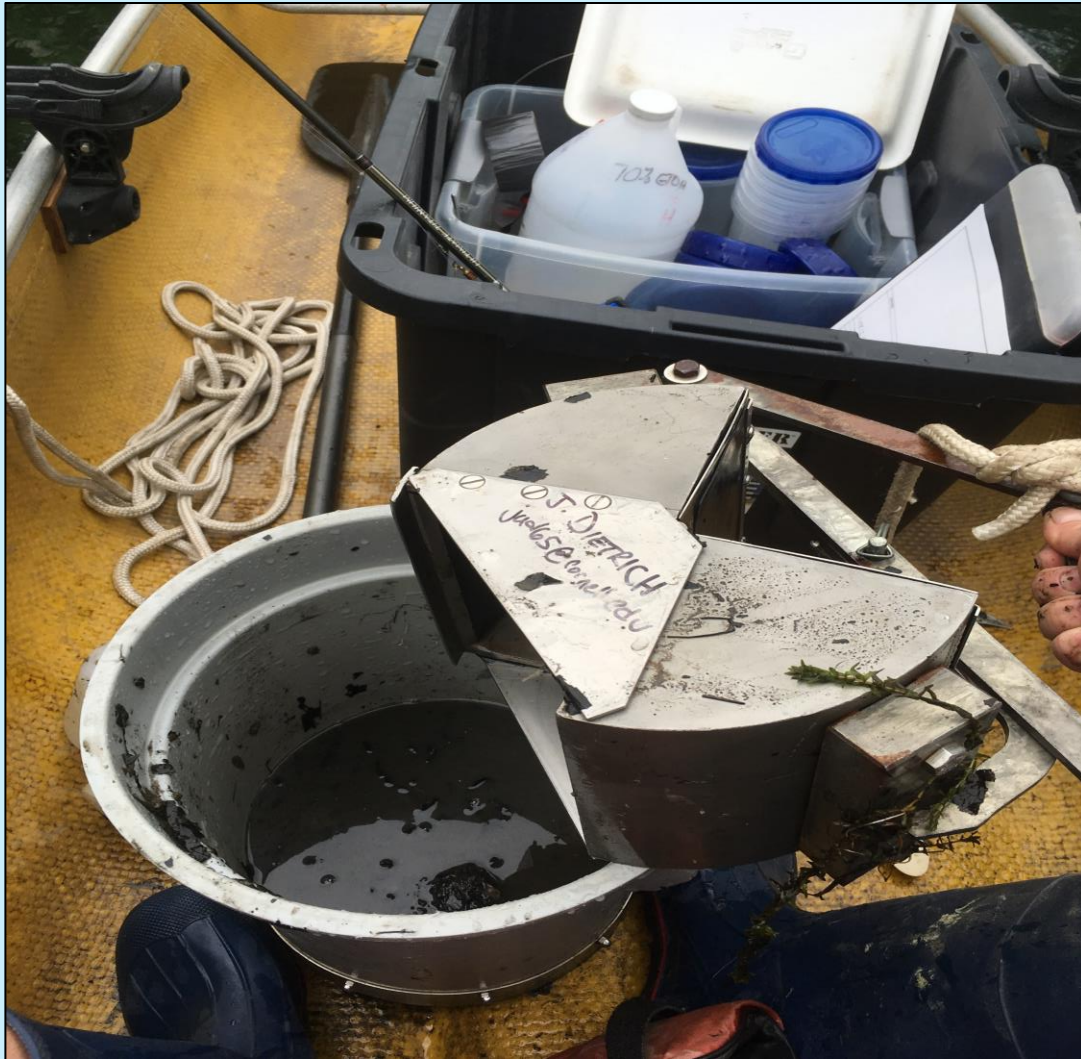
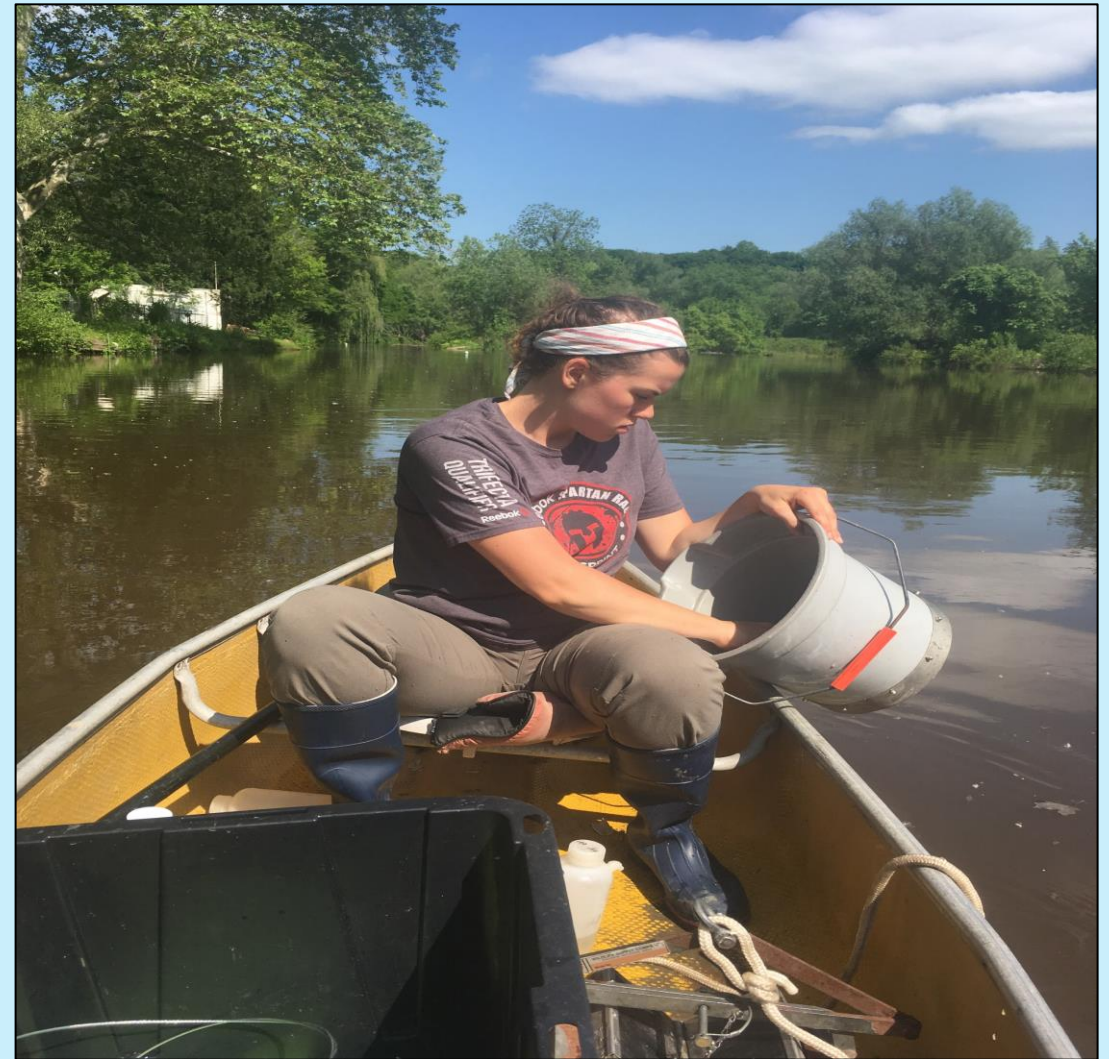
# Field Collections: Upstream Ponar Dredge

Capturing benthic organisms.

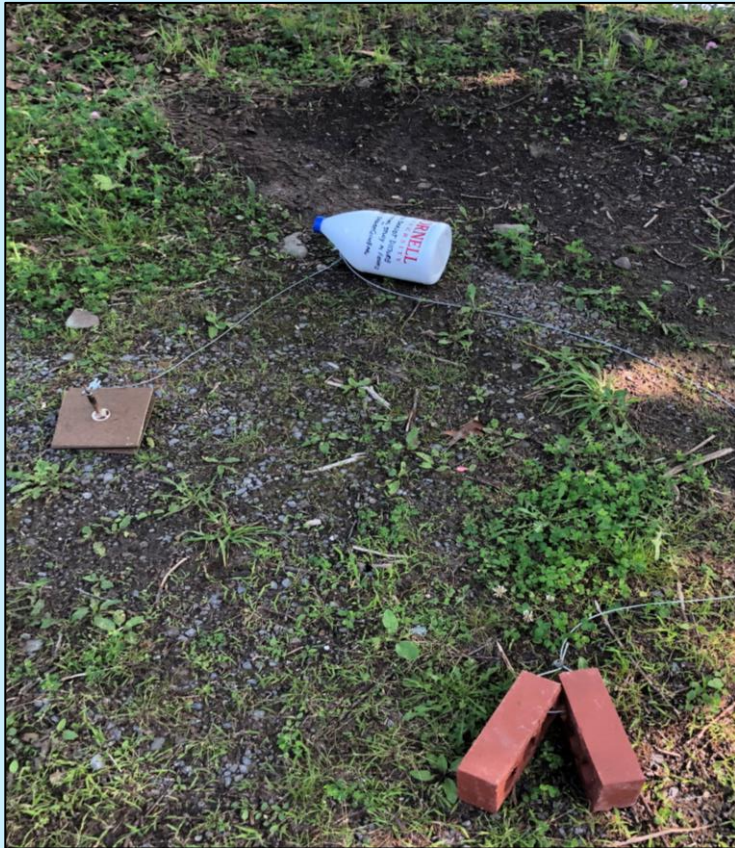
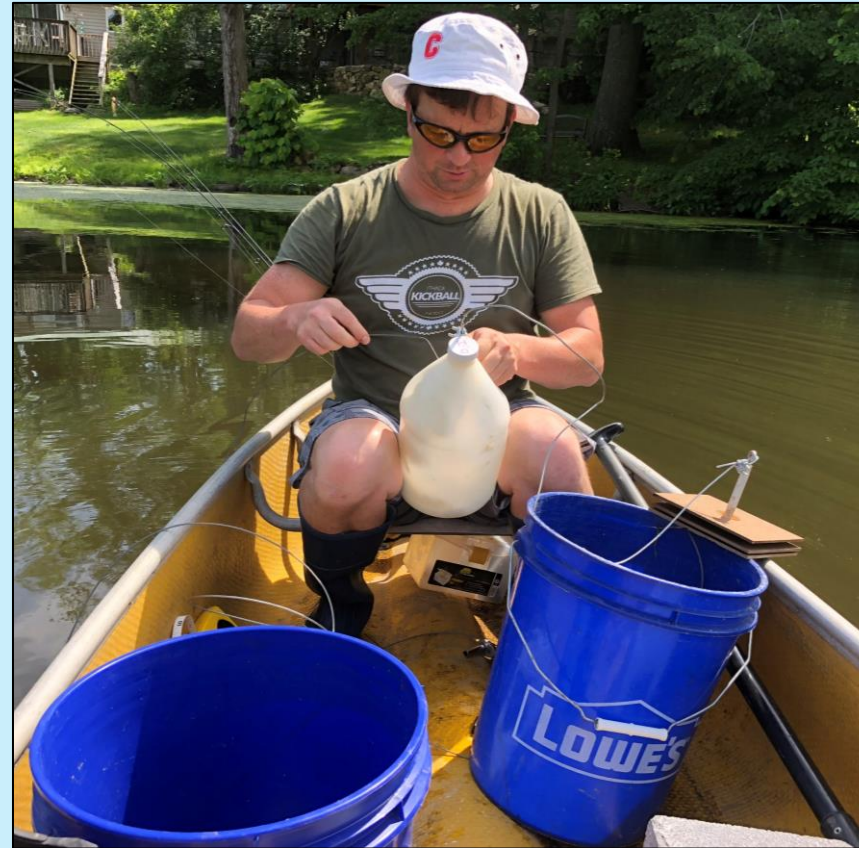
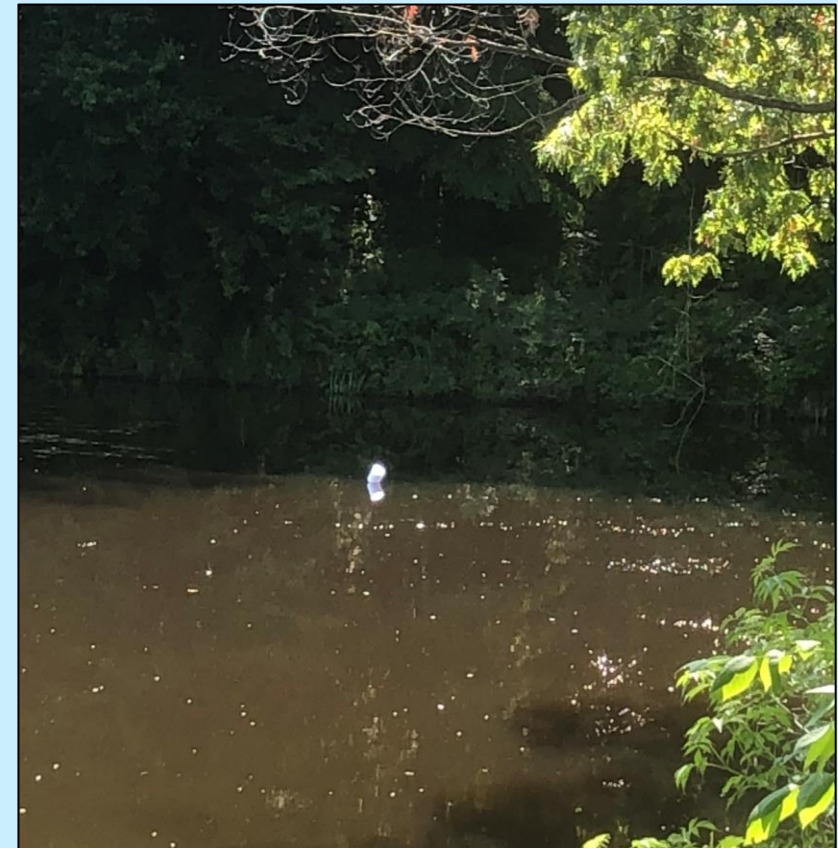
# Field Collections Upstream: Multi-Plate Sample

Capturing organisms in drift and within water column.

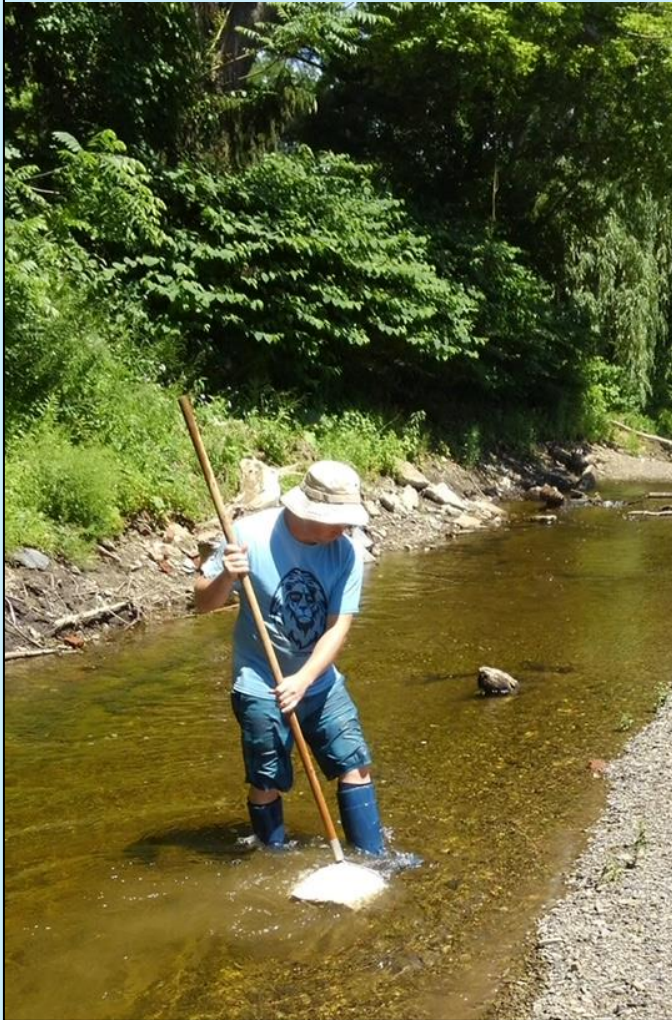
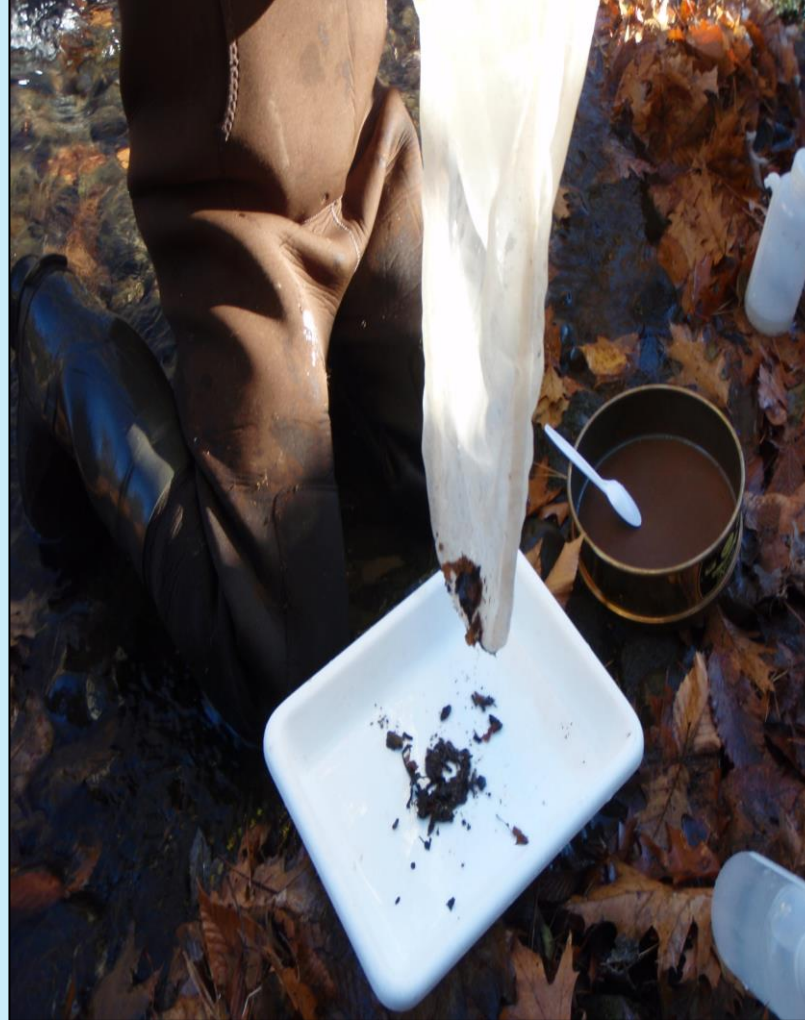
# Field Collections: Downstream Kick-Sample

Captures both benthic and drift organisms.

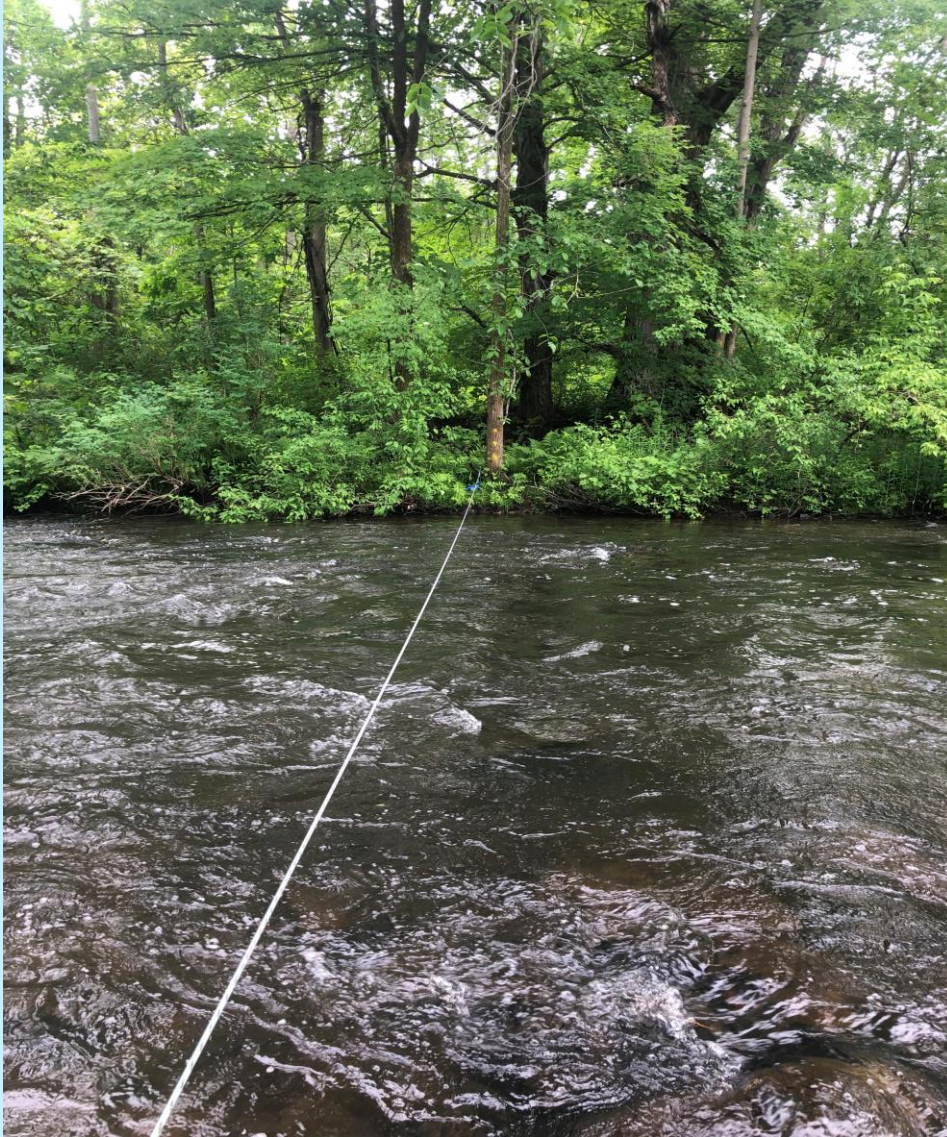
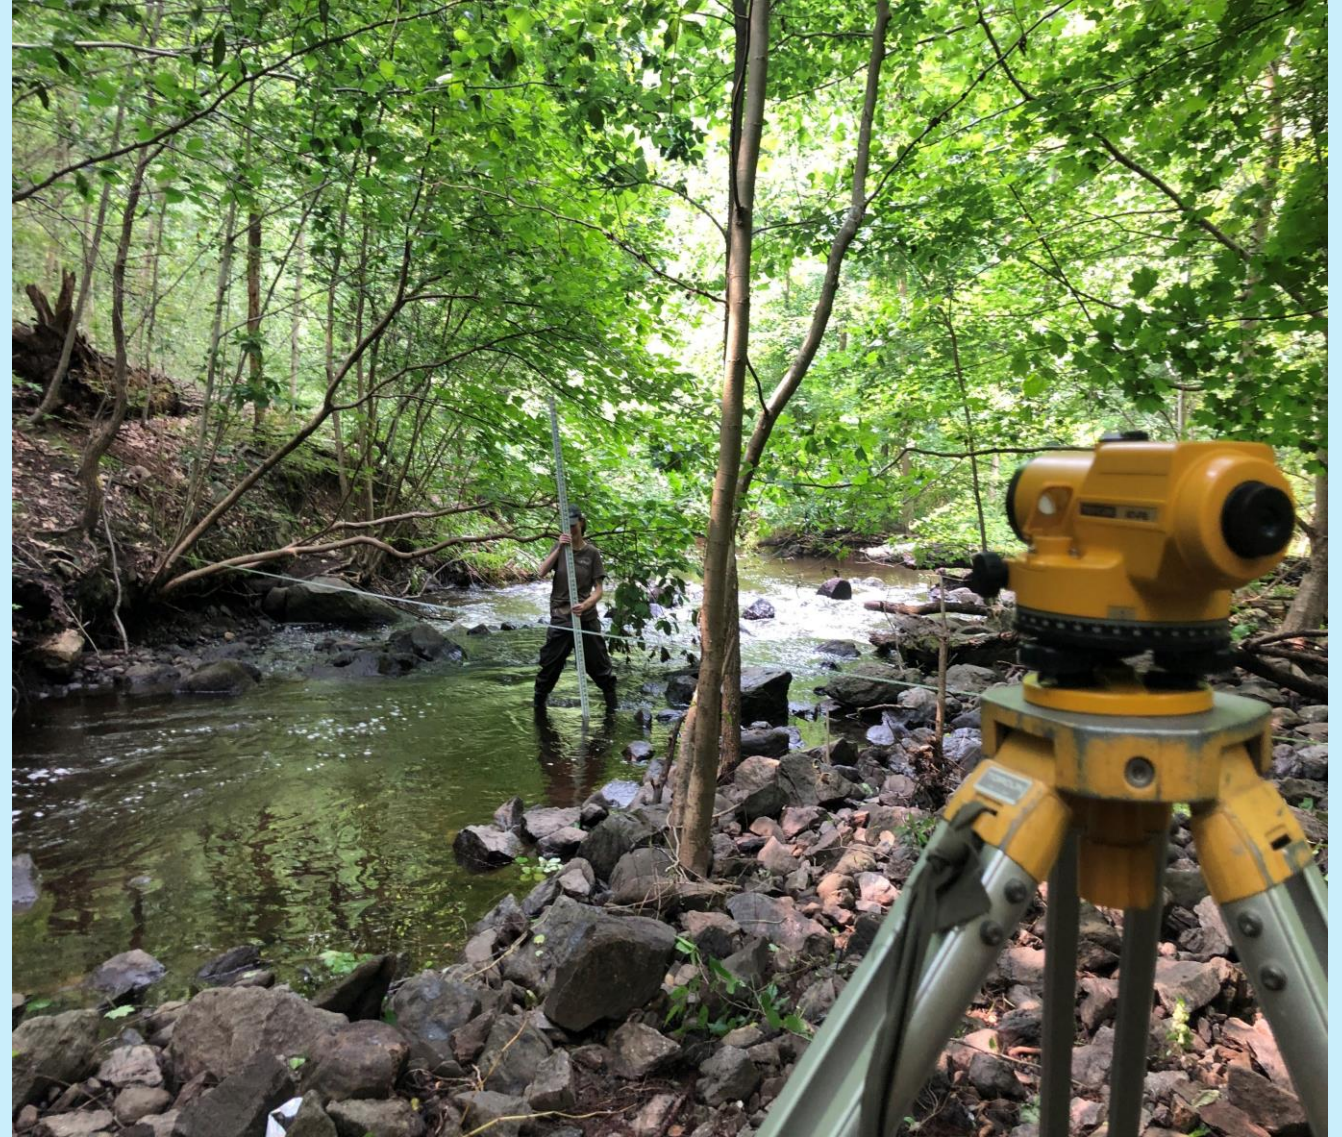
# Transect Substrate and Channel Survey

Recording instream substrate type and channel elevation at every 1-ft; each end of transect is fixed with steel spike.

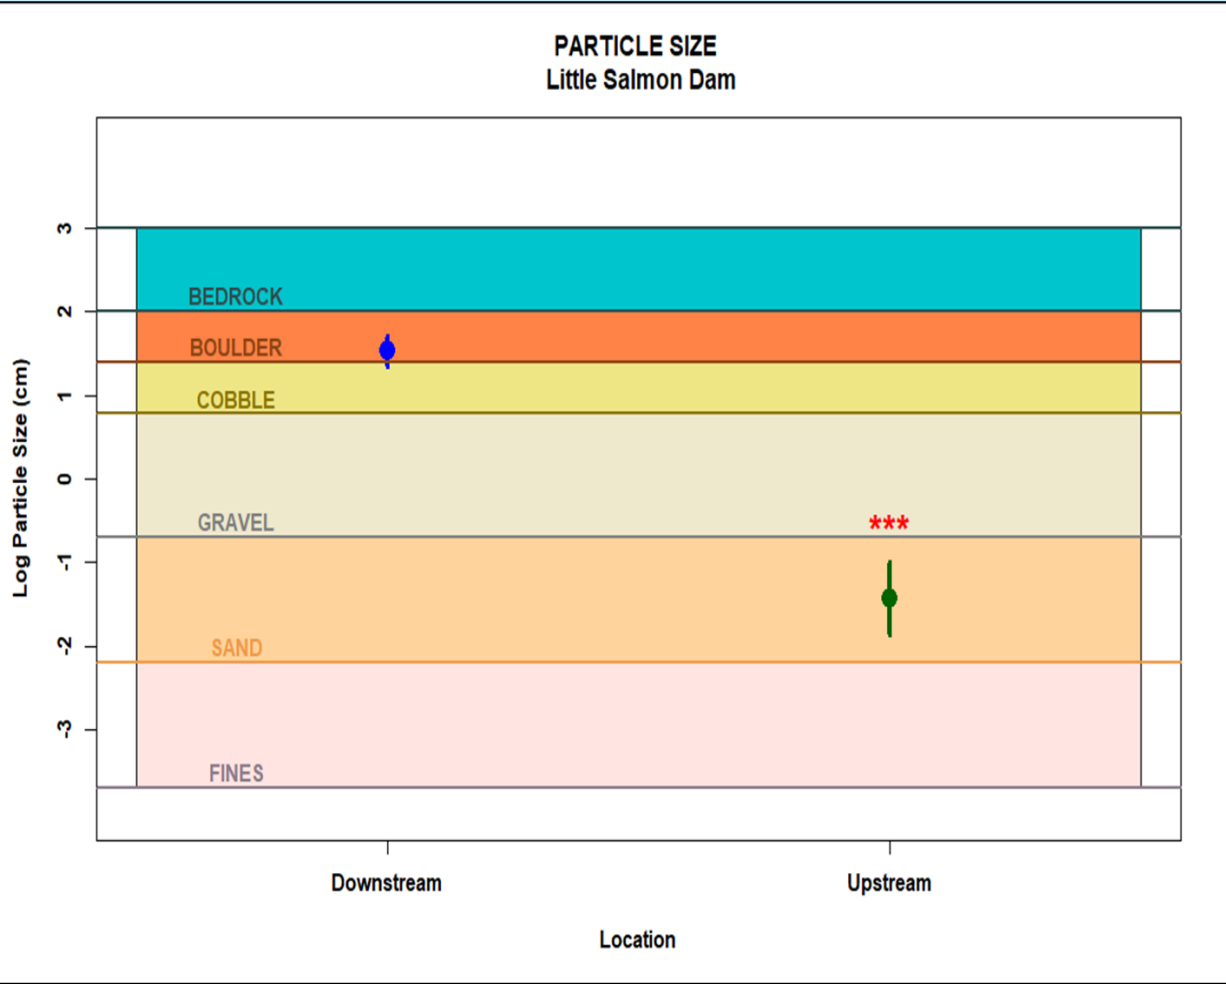
# Quantitative Sediment Particle Size Trends

Upstream impoundment areas possess significantly lower particle size (0.07cm) than downstream reaches (37cm).

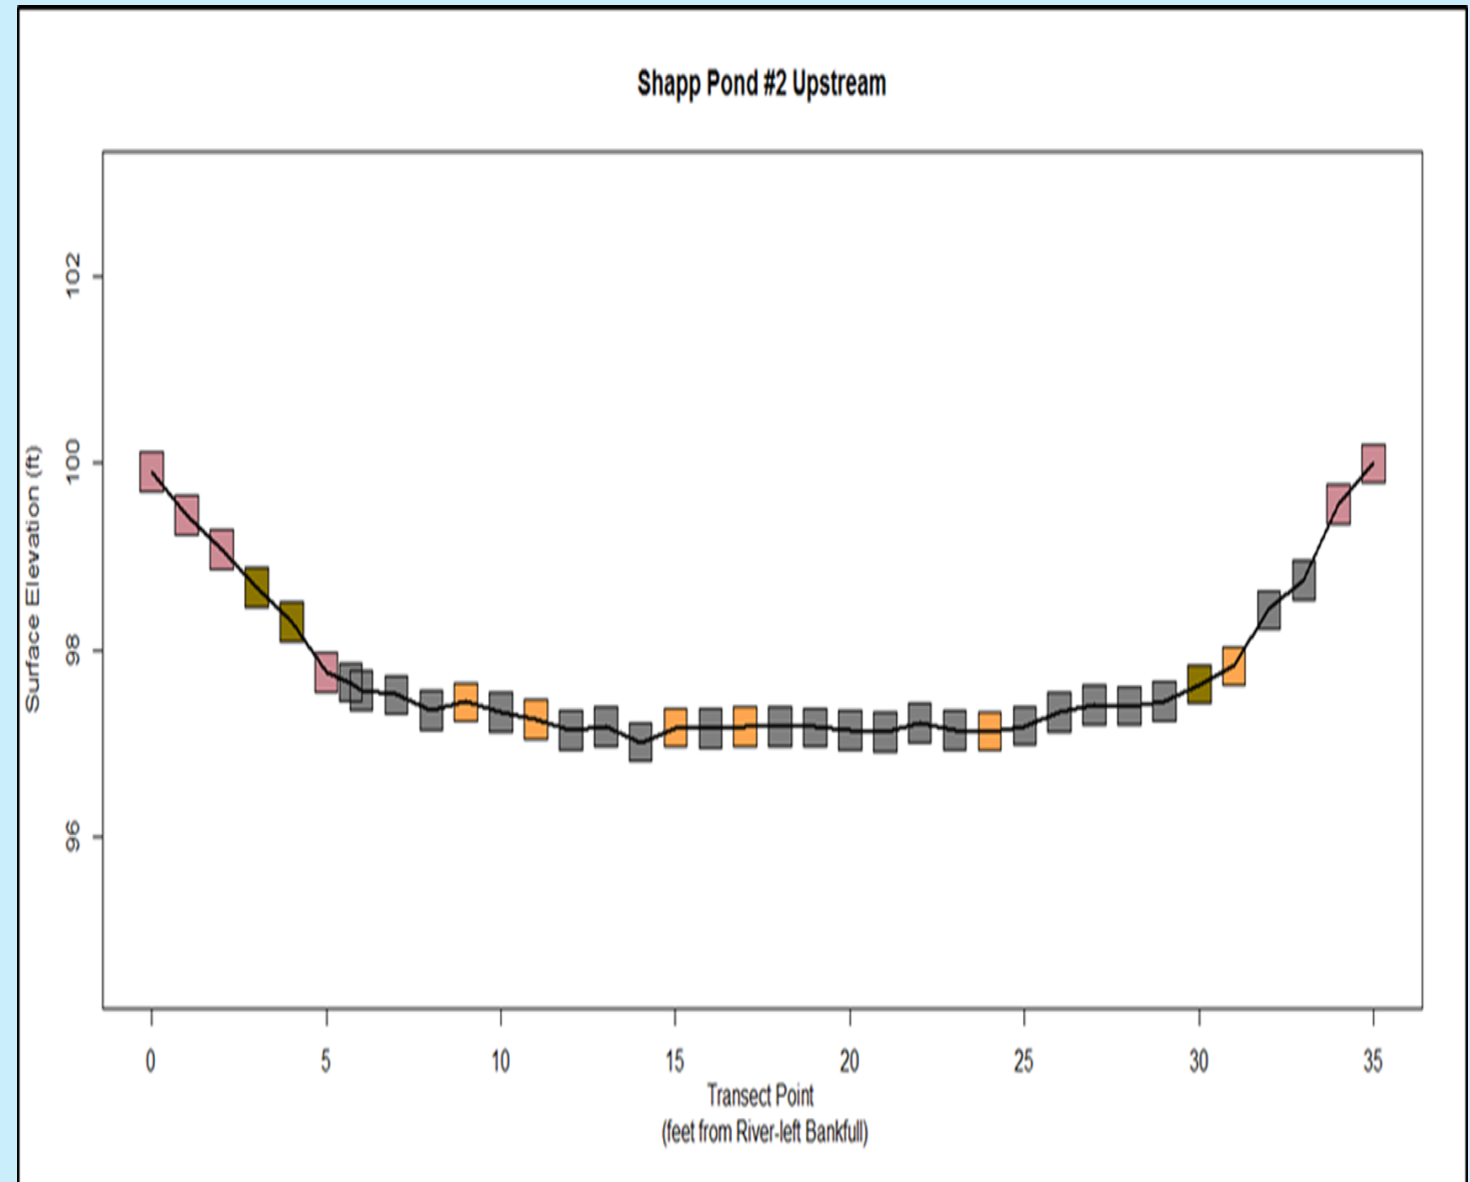
# Channel Morphology Transect Surveys

- Provide an elevational cross-section of the channel.
- Illustrate the distribution of different sediment types across the channel.
- Can track changes in channel morphology (erosion/deposition) and sediment distribution following dam removal.

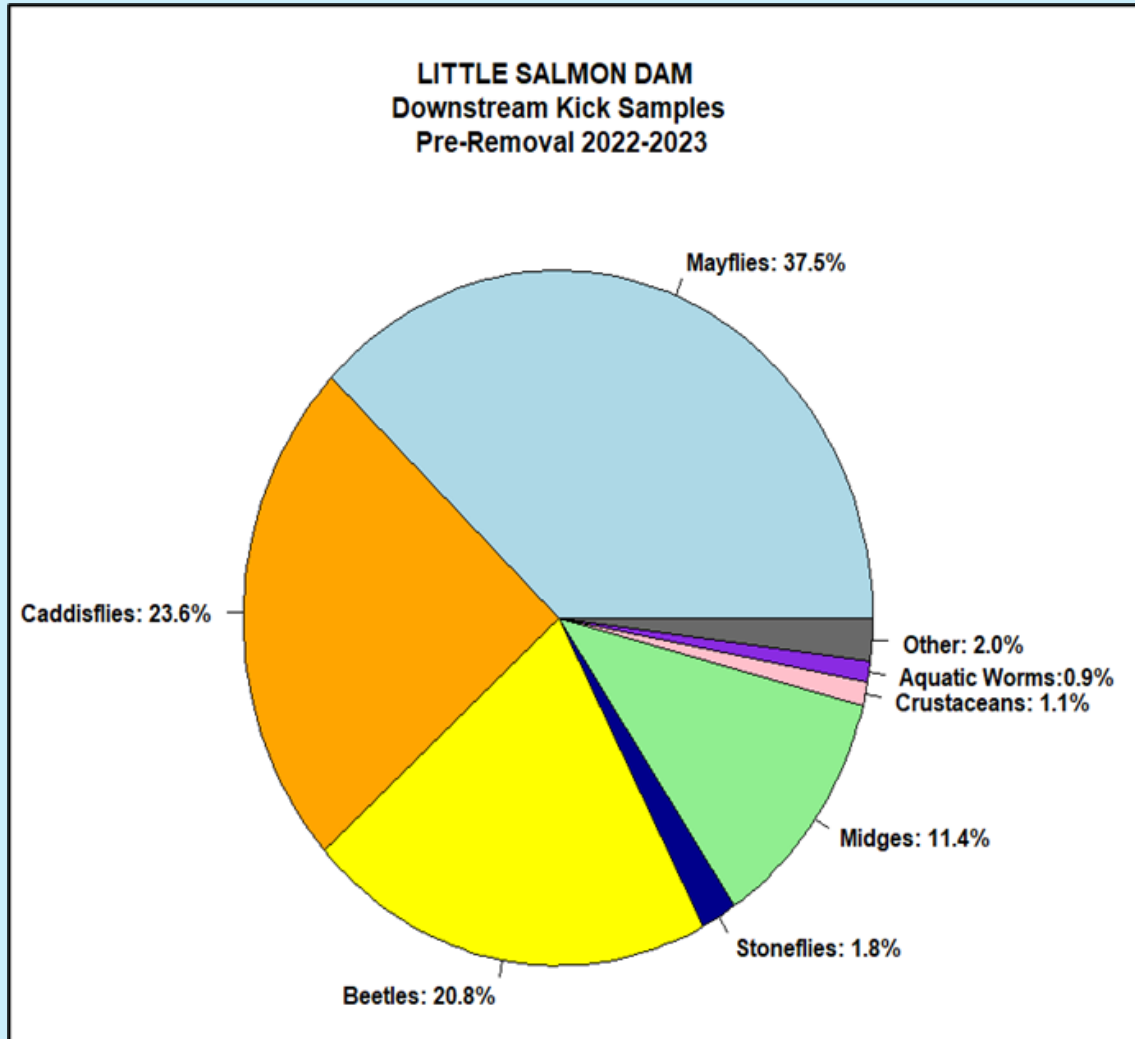
Downstream populated by common invertebrates found in good quality streams.

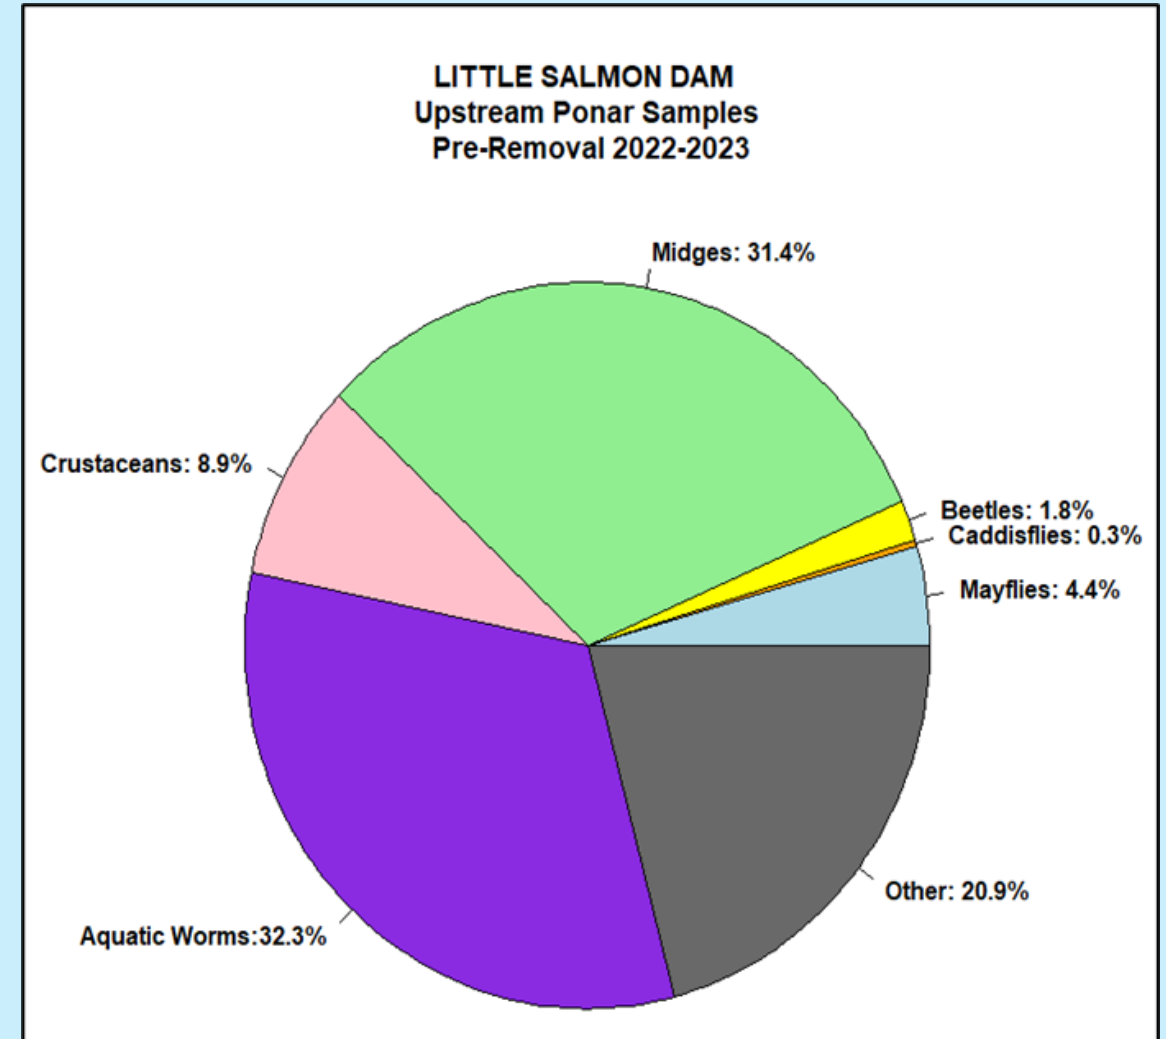
Upstream populated by common pond organisms tolerant of fair to poor water quality.
